## **Urgent Field Safety Notice**

### **Invacare® PerfectO2™ and Platinum® Concentrator**

**Invacare Ref: FSN 82590**

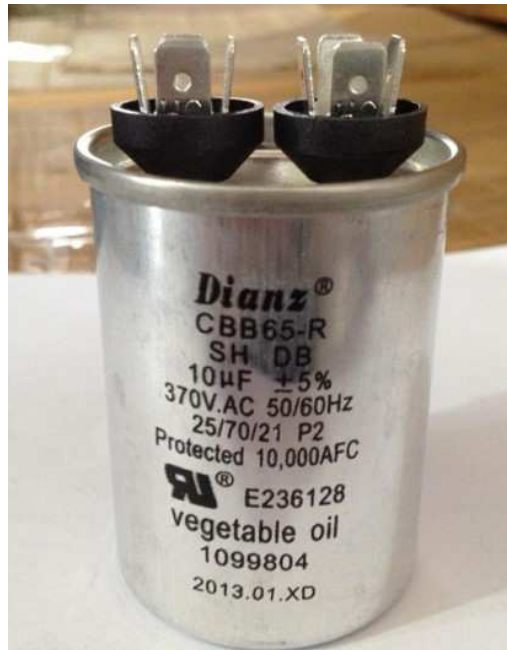
Picture: DIANZ Capacitor

As a result of its investigation Invacare determined the root cause of these capacitor ruptures is due to the design of the PSI (Pressure Sensitive Interrupter) of the capacitor provided by the subject supplier prior to July 2012.

The capacitor in the oxygen concentrator has an internal pressure relief component (the PSI) which may not operate as intended permitting the capacitor to rupture in certain circumstances. If the PSI does not function to relieve the pressure, then the pressure can cause a rupture in the seam between the housing and the end plate.

If the rupture occurs, the oil may be expelled from the capacitor that may result in a fire hazard.

The Capacitor needs to be replaced as soon as possible at the latest when the next maintenance is due and no later than 12 months after receipt of this notice.
